THE
CITY of PELLA

STAFF MEMO TO COUNCIL

ITEM NO: E-4
SUBJECT: Facility Needs Assessment Results
DATE: July 2, 2019

City of Pella Facility Needs Assessment

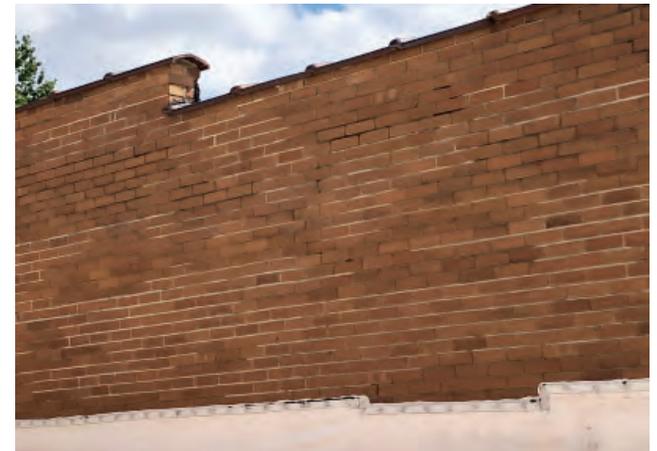
The exterior walls of the original 1906 building are constructed of load bearing brick masonry. This masonry is in fair condition but several areas are in need of tuck-pointing. It is recommended that portions of the walls be re-pointed in the coming year to prevent water infiltration and further structural deterioration of the building. Primary areas in need of re-pointing were along the west façade and at the roof level. The masonry cladding of the exterior walls of the building addition to the original Carnegie Building are in good condition. The floor and roof structure was not visible at the time of the site visit for review. There did not appear to be any signs of structural deterioration, or settlement of the building.

Masonry in need of tuck-pointing

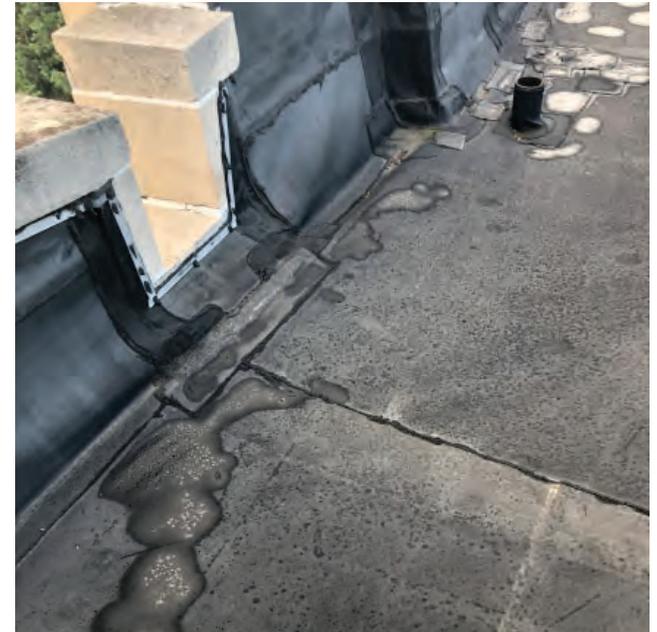
Aged Roofing

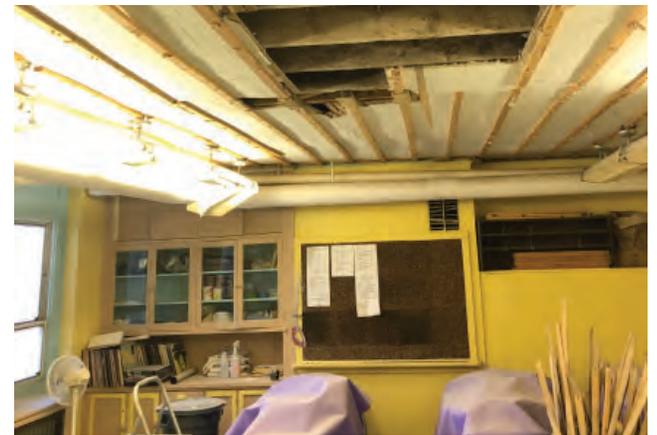
Damaged Ceilings

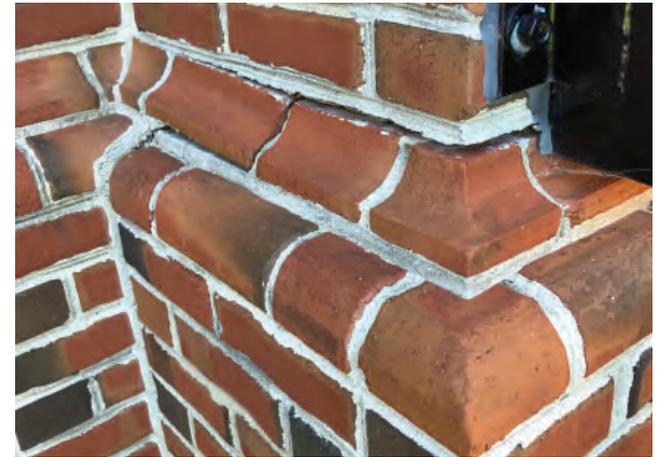
Masonry Repair

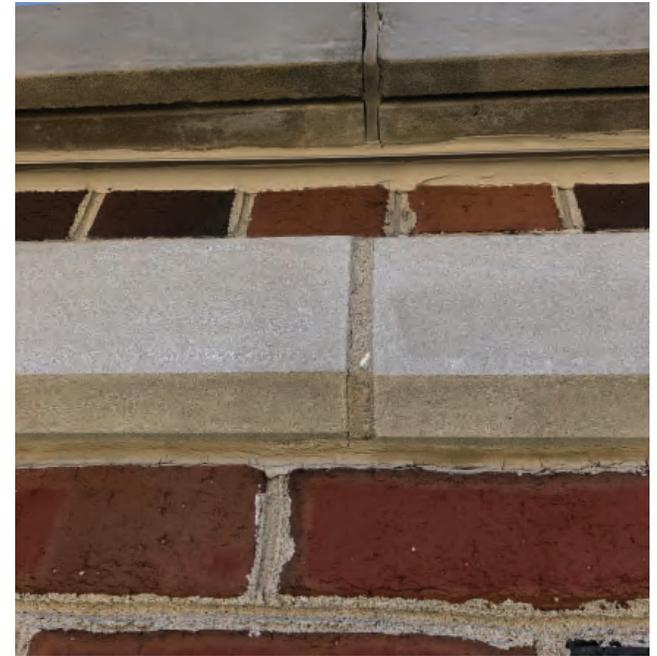
Masonry Repair

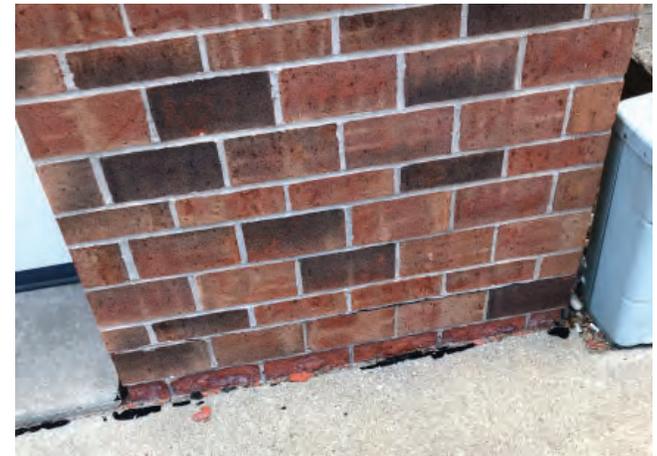
Masonry at base

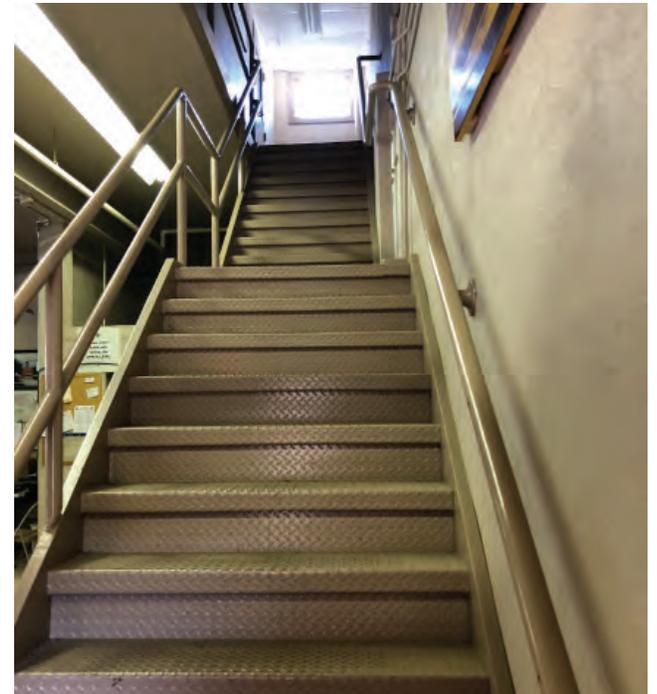
Missing stair rails

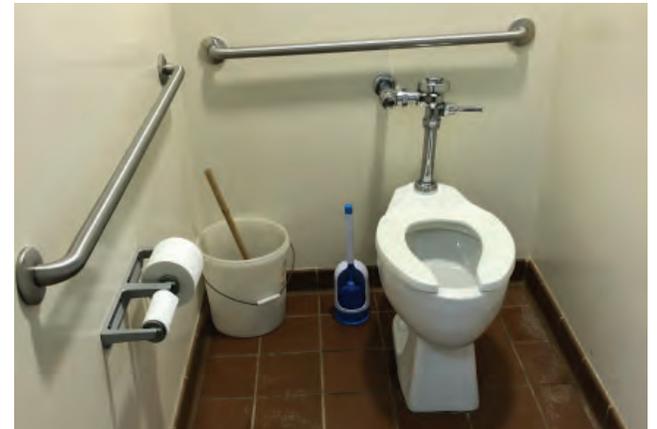
Non-Compliant Rooms
