OFFICE OF THE INSPECTOR GENERAL
CITY OF BALTIMORE

Investigative
Report Synopsis

OIG Case # 26-0022-I

Site Visit DOT Signs and Markings Facility

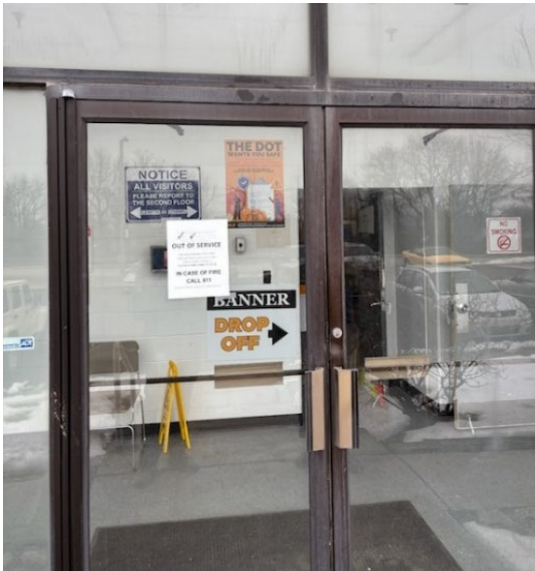
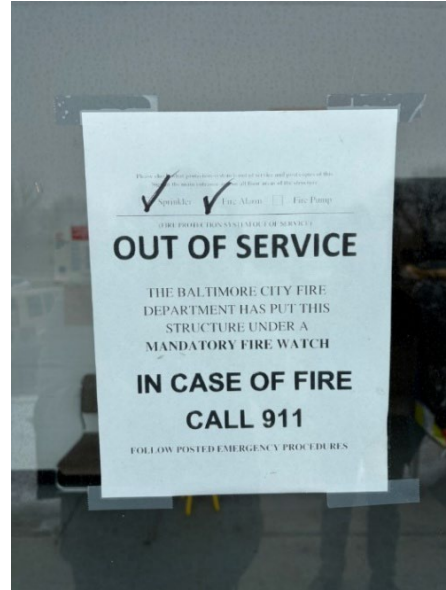
Figures 2&3: Front door of DOT Facility and fire watch sign from February 17, 2026, OIG site visit

The OIG conducted a site visit to the DOT facility on February 17, 2026. Affixed to the entrance door was a fire watch sign noting that the facility does not have working sprinklers or alarm system (Figures 2&3). When the OIG asked DOT personnel about the fire watch they stated the building has been like this for years.

The OIG recommended that DOT work with BCFD and the Department of General Services to fix these issues, especially since the facility has flammable items, including lumber, inside. Without a working sprinkler and alarm system, these conditions present a direct hazard to workers and City property.

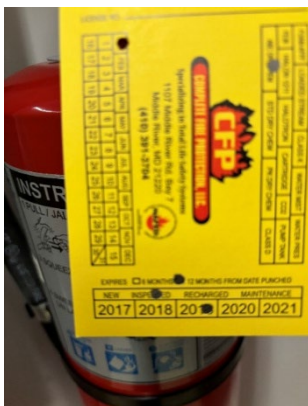
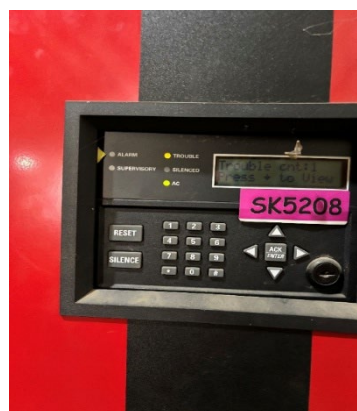
Figures 4 & 5: Expired (2019) fire extinguisher and fire alarm system control pad from 2024 BCFD inspection

After the site visit and becoming aware of the fire watch, the OIG obtained the original BCFD report that documented the initial violations of International Fire Code (IFC) including an expired extinguisher (Figure 4) and alarm system malfunction (Figure 5). The photos depicted an extinguisher that was last checked in 2019 and was expired by three years at the time of BCFD’s inspection. The alarm control pad indicated “trouble” on the screen and was lit up next to the word trouble in a user notification.

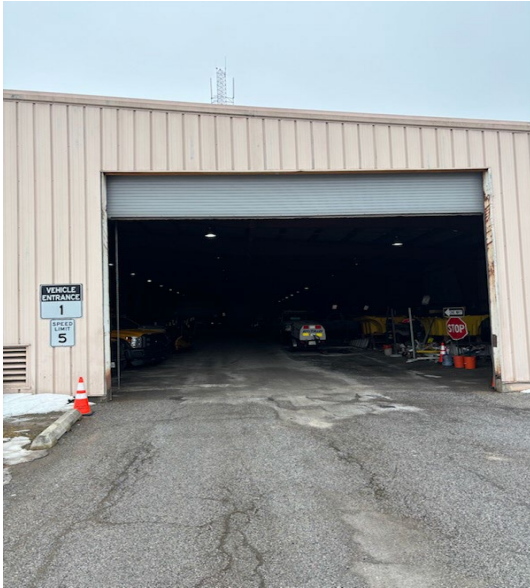
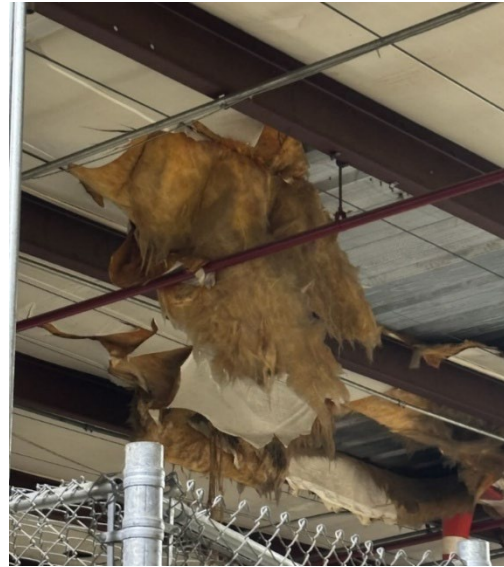
Figure 6 & 7: Stuck open bay door & insulation covering sprinkler system from February 17, 2026 OIG site visit

Many of the noted issues found and documented by BCFD during the initial inspection were still present at the time of the OIG's site visit. The OIG observed the fire watch notice and saw a stuck facility door and the sprinkler system had insulation covering it in a section (Figures 6&7).

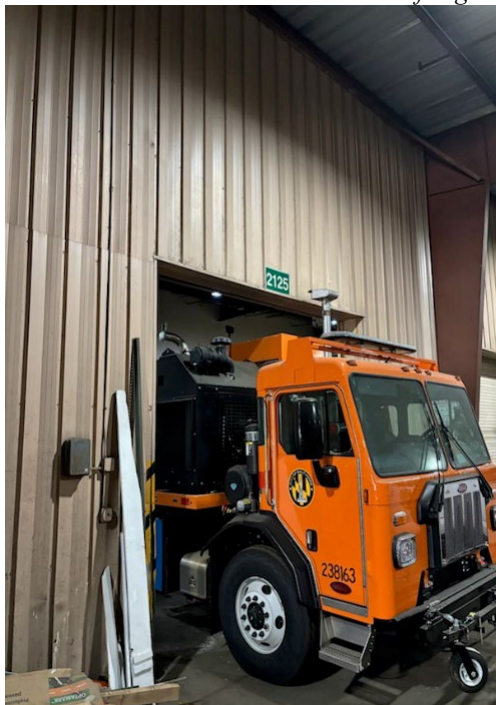
Figure 8: OIG site visit - truck that is too tall for garage bay door

The OIG was shown a bay where one of the road marking trucks is kept. The vehicle is not able to fit into the bay completely due to its size and thus the door is unsecured (Figure 8). Due to the truck not being able to fit fully and the bay door having to be left open the temperature in the facility is approximately 10° warmer than the outside temperature at any given time. On the day of the visit, the OIG measured the room temperature at 46° Fahrenheit while the outside temperature was 37° Fahrenheit (Figure 9).

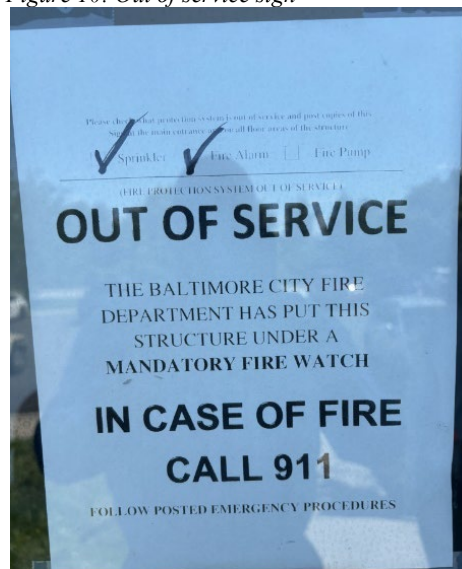
Figure 10: Out of service sign

The OIG conducted another site visit on June 2, 2026 (approximately 64 days since DOT response). The OIG observed the out of service sign still posted on the door to the DOT Facility (Figure 10).

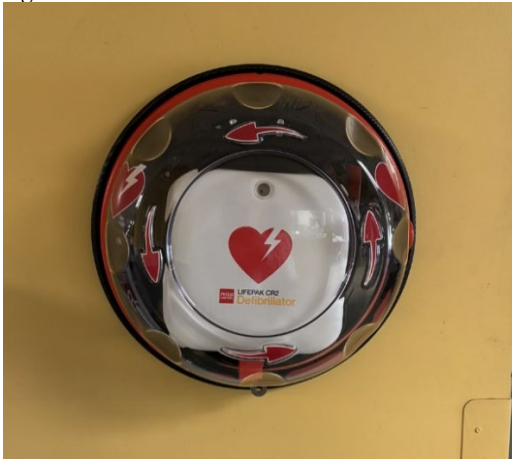
Figure 11: AED installed

The OIG noted the addition of an Automatic External Defibrillator (AED) in one of the main corridors (Figure 11). The addition of a compressor installed to the sprinkler line was observed (Figure 12) and fire extinguishers in the building were all serviced in September 2025 (Figure 13).

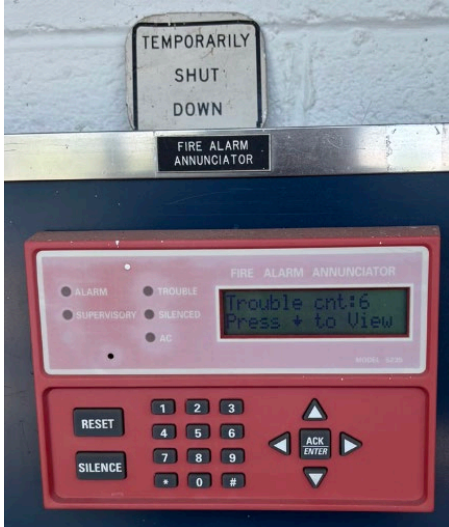
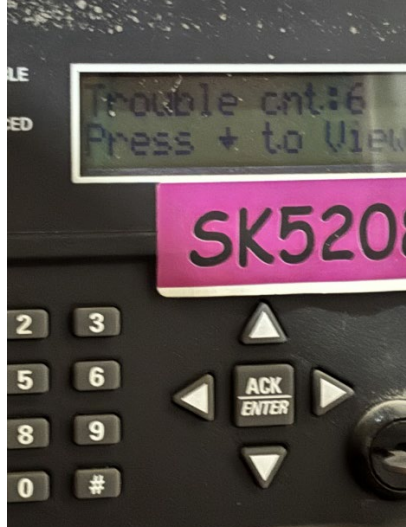
The fire watch sign was still posted on the door, and the fire alarm system was displaying a “trouble” indicator and audibly making a high-pitched beeping sound approximately every 2-3 seconds (Figures 14-15). The OIG included a video of the high-pitched beeping as an exhibit to this report (Exhibit 1).

Figure 14: Trouble codes on fire alarm system

Figure 15: Trouble codes on fire alarm system

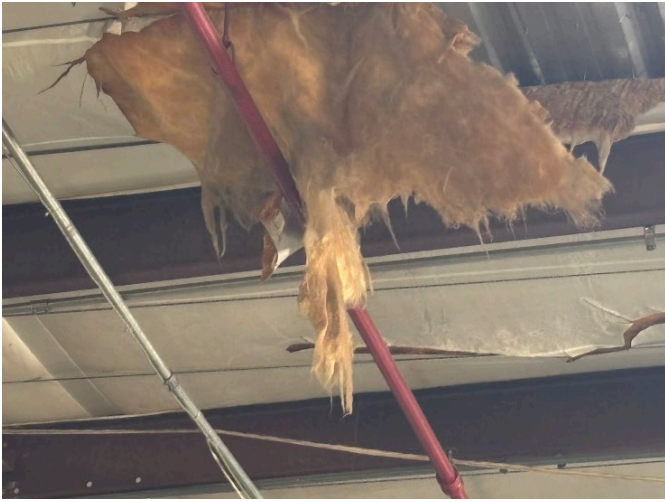
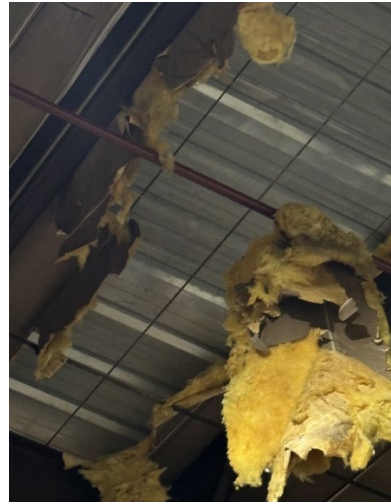
Figures 16&17: Hanging insulation

The OIG also noted insulation is still hanging and wrapped around the sprinkler system from the roof (Figures 16&17).

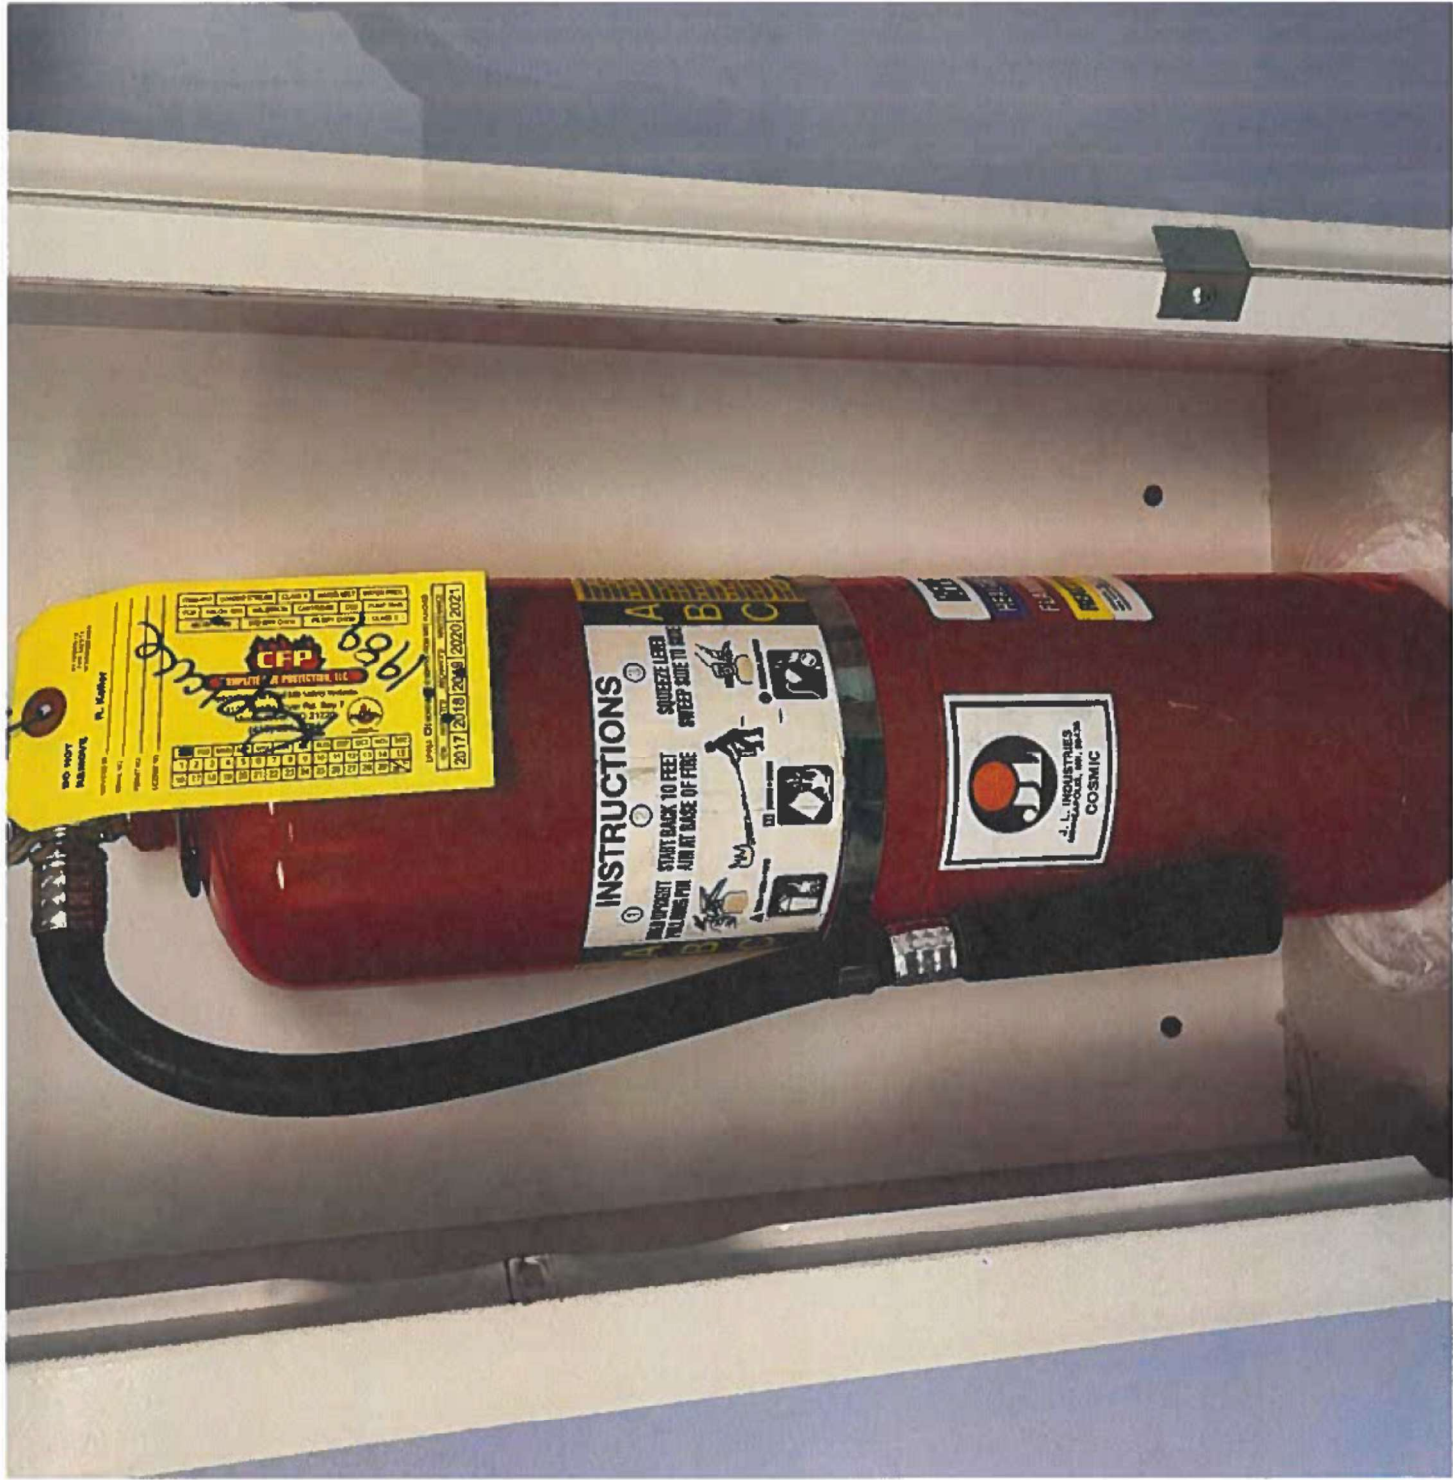
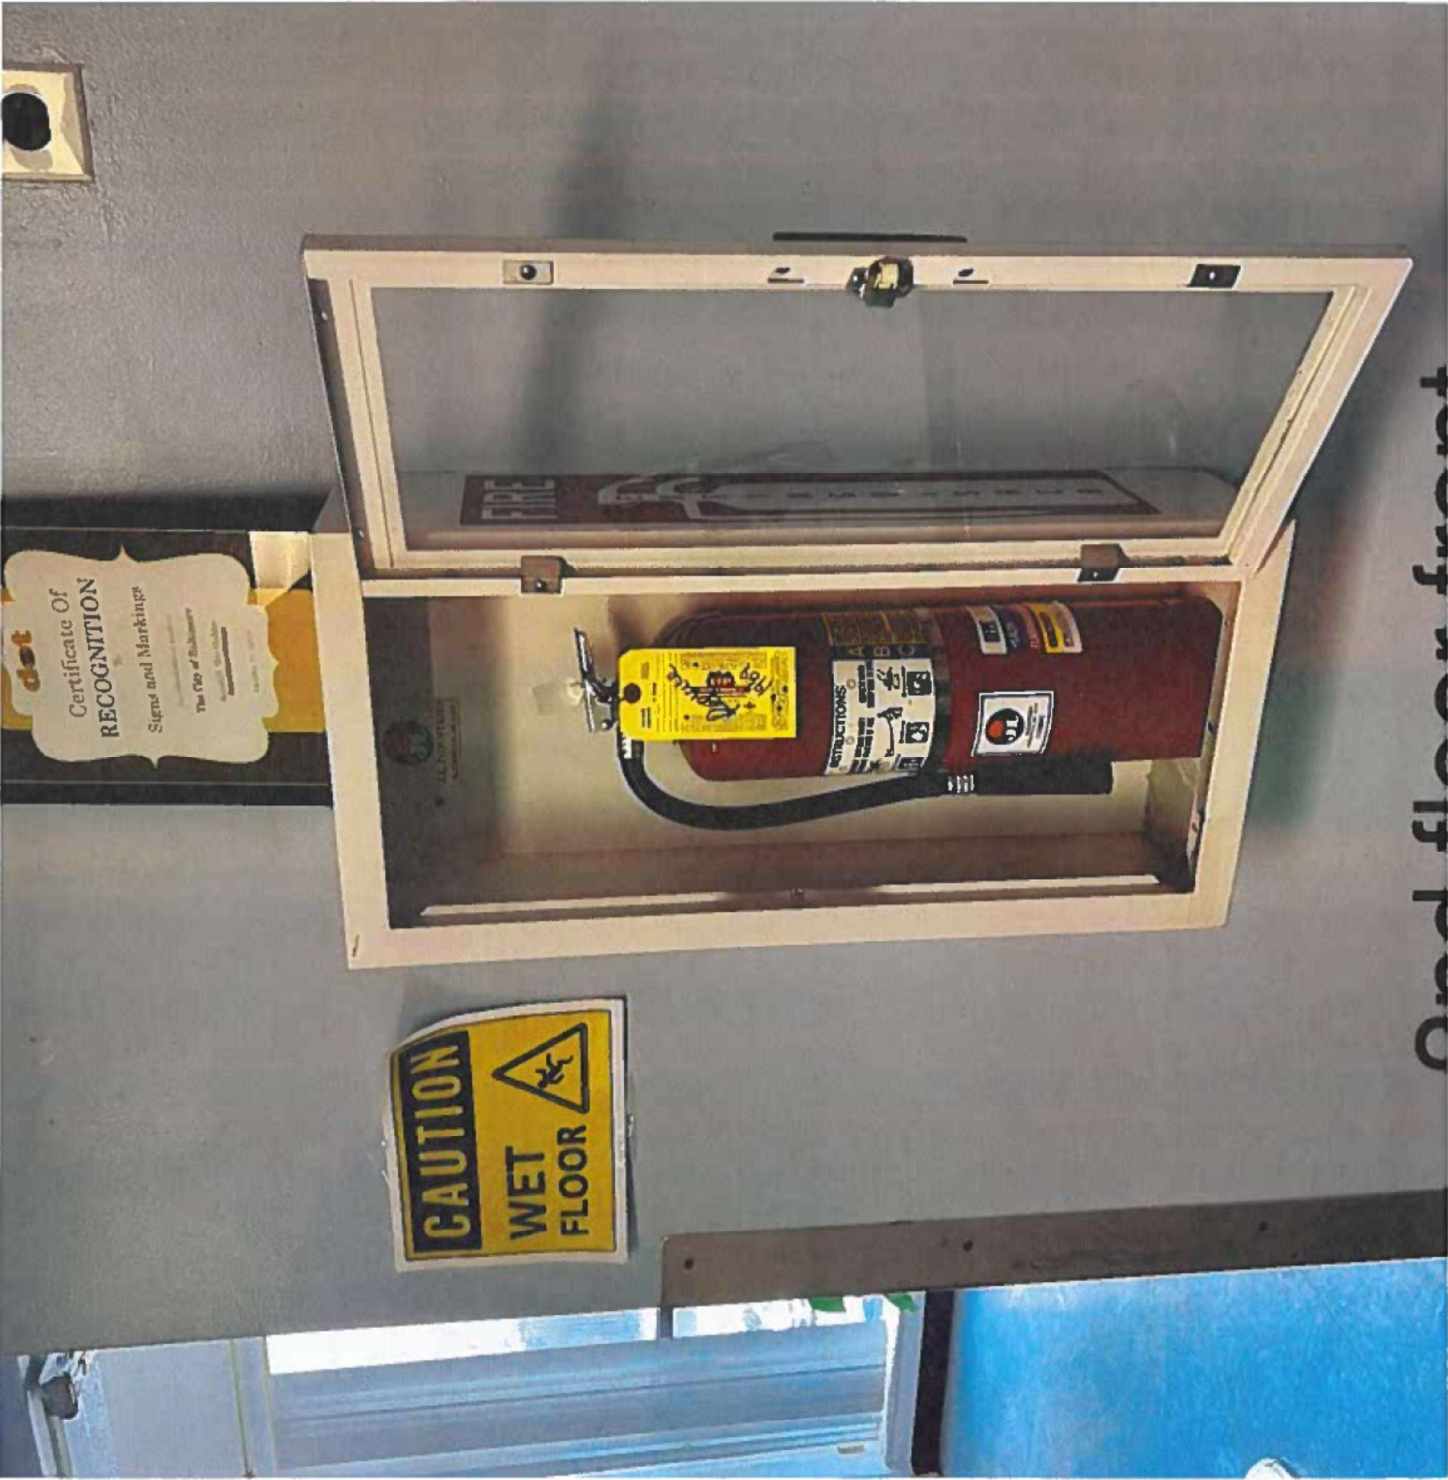
#2a

Additionally, 53 new fire extinguishers were installed in 2025, with future inspections taking place on an annual basis, the next inspection date is September 2026. The Department will also seek training in the use of Fire Extinguishers for all staff located at this facility
