THE
CITY of PELLA

STAFF MEMO TO COUNCIL

ITEM NO: E-4
SUBJECT: Facility Needs Assessment Results
DATE: July 2, 2019

City of Pella Facility Needs Assessment

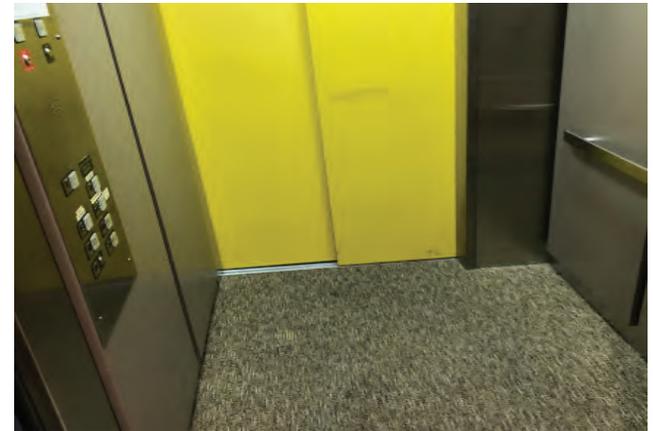
Elevator Cab Interior

There is a three-stop, hydraulic elevator that serves the main entry, upper and lower levels of the building. The elevator has a 1,500 pound capacity with a 100 feet per minute travel speed. Interior cab finishes included laminate clad side wall panels, stainless steel front and back walls, painted doors and carpet flooring. Finishes are in good condition and do not show signs of significant wear. The elevator inspection card was displayed in the cab and indicated the unit was up-to-date on its required yearly inspections. Given that the elevator sees a relatively low volume of use it should continue to function properly, with regular maintenance, for the foreseeable future.

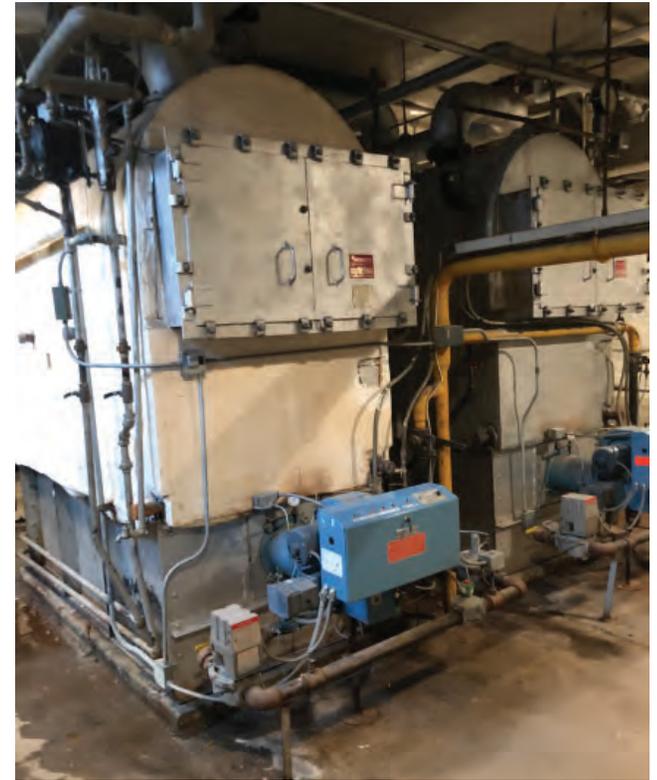
Boiler

In general, All HVAC systems in the community center are outdated, past their anticipated life and should be replaced.

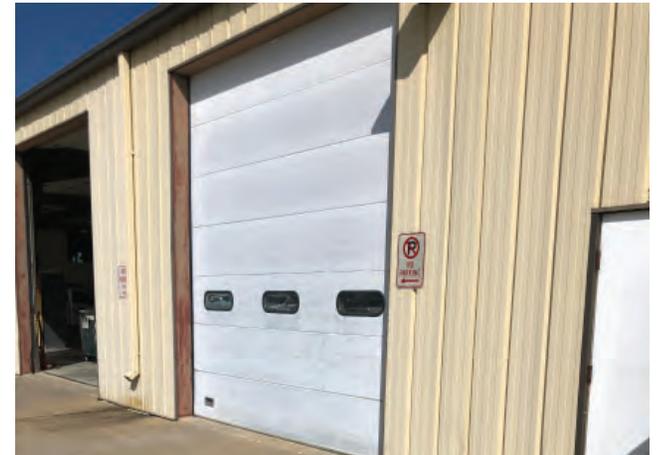
Garage Door

Overhead vehicle doors are also in fair condition. The exterior door finishes are aged and weatherstripping in several areas needs to be replaced or adjusted to provide a weathertight seal.

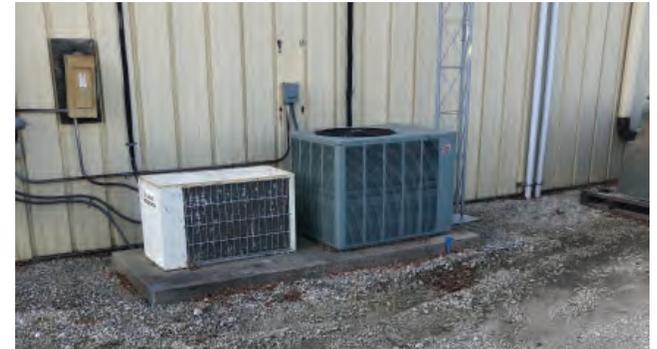
Mechanical

It does not appear that ventilation air is ducted to the return of the furnace from the exterior of the building. Also, the furnace has a corrugated stainless steel natural gas hose connection, which may be against local jurisdiction.

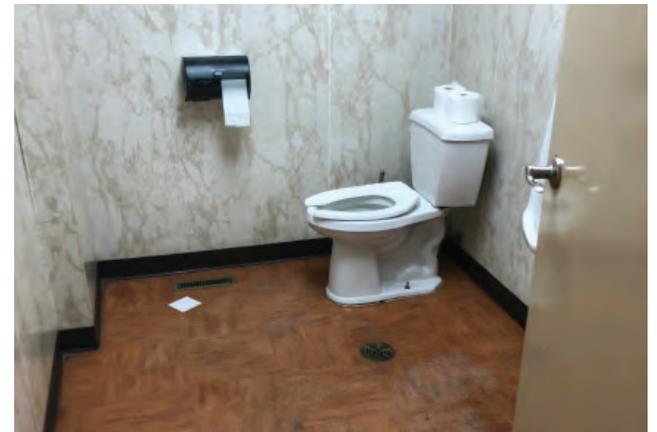
Restroom

Plumbing fixtures are vitreous china lavatories, tank-type toilets and urinals. There are stainless drinking fountains with bottle fillers and stainless steel drop in sinks. The electrical water cooler in the office area is missing a cover, so it is unknown if it is being worked on. The urinal flush valve is manual and other faucets are manual. The plumbing under the lavatory does not have ADA insulating wrap on the drainage or water supplies and the hot water is missing an ASSE 1070 hot water mixing valve, which is a new code item for public lavatories. The plumbing fixtures appear to be in decent condition.

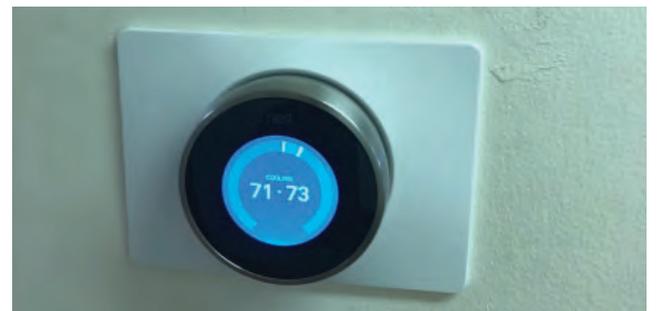
Thermostat

The controls for the furnace, unit and radiant heaters are stand-alone thermostats. A DDC system could provide for system scheduling and alarms, which would provide an opportunity for enhanced energy savings and alert staff with any issues before potential for damage. With the usage of this building and limited HVAC, a DDC system might not make the most economic sense.

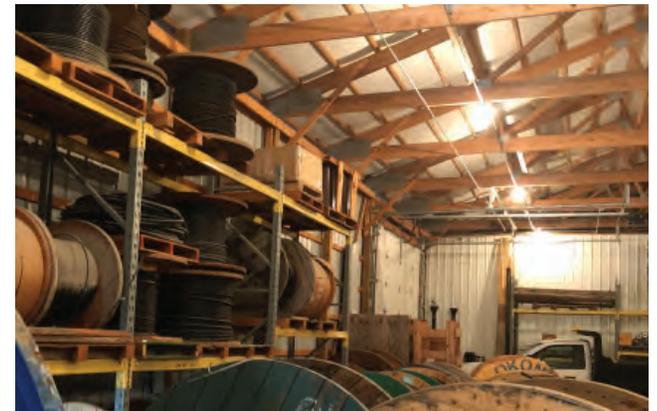
Cold Storage

ished corrugated metal panels and are uninsulated. The buildings structure, cladding and flooring systems are in good condition and show no signs of significant deterioration.

Exterior doors are painted steel and in need of a fresh coat of paint. There is one overhead vehicle door on the south side of the building that was recently replaced and is in good condition.

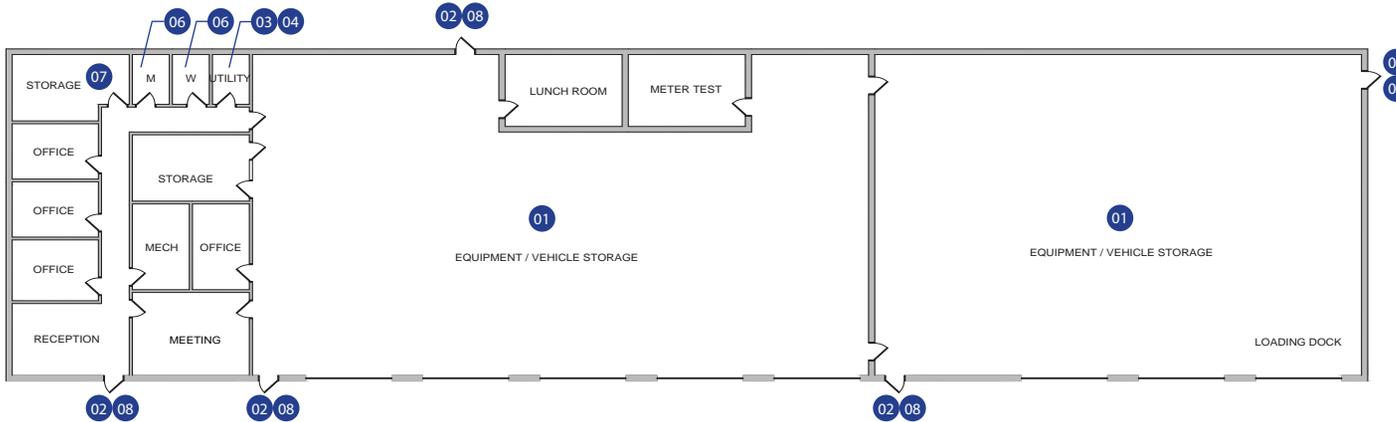
Main Level

- 02 Typical throughout building
- 05 Typical at office area

- 01 Install a vehicle exhaust system with CO/NO2 detectors in the vehicle parking areas.
- 02 Install code compliant interior and exterior emergency egress lighting throughout the building.
- 03 Provide proper grounding of the electrical systems.
- 04 Conduct an arc flash study and install proper labels on electrical gear.
- 05 Replace interior floor and ceiling finishes.
- 06 Provide accessibility upgrades to the existing facility restrooms to meet the minimum requirements of the American's with Disabilities Act (ADA) and State Building Code.
- 07 Provide new cabinets in break/lunch room areas to meet minimum handicapped accessibility requirements. Current codes require countertops to allow for wheel chair access at sink locations.
- 08 Paint exterior steel doors and frames to protect doors from corrosion.

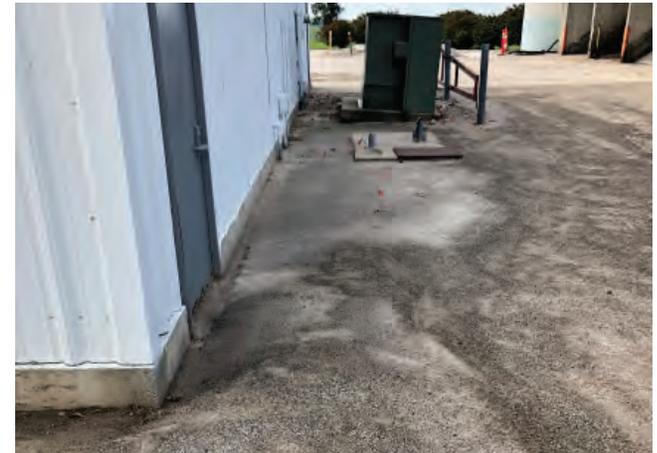
Washout Area

Directly to the west of the shop building there appears to be a low spot in the site that has allowed water to pool. The wet conditions in this area are likely the cause of an electrical transformer beginning to lean and settle and corrosion at the existing man door. It is recommended that the site be regraded in this area to ensure proper drainage away from the building.

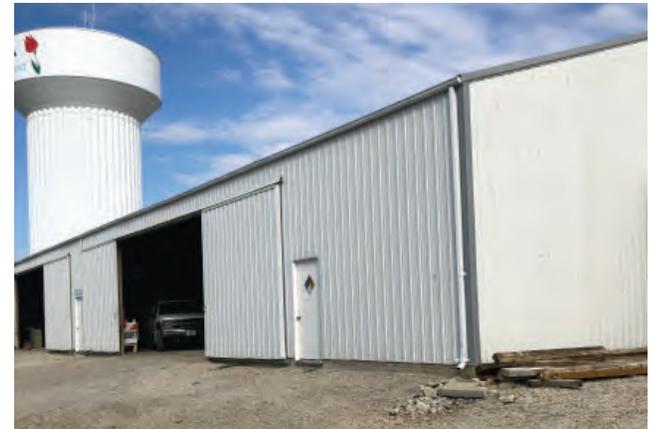
Cold Storage

There is evidence of minor undermining of the exterior wall along the south side of the building adjacent to the center downspout. This is likely caused by water from the downspout washing out the soil below the building wall. This is a common issue with post framed wood structures and it is recommended that washed out soil be replaced and the issue monitored to prevent future structural damage.

Overall the buildings structure and cladding systems are in good condition and show no signs of significant deterioration. It is recommended that a concrete floor slab be poured to provide greater protection for the equipment being stored.

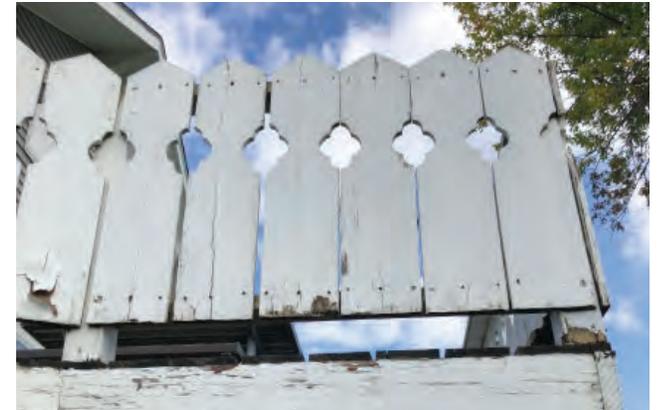
Deck

Exterior doors are metal clad wood doors with insulated glazing and are in good condition. Along the south and west sides of the building is a wood framed deck which is used to provide access to the buildings main second level entry door. Overall the deck is in poor condition. Its structural framing, decking boards and guardrails have significant deterioration. At the time of the site visit the deck area was chained off to discourage visitors from using the structure. It is recommended that the deck either be repaired/replaced or be removed completely and a new structure built to provide adequate access to the buildings main entry.

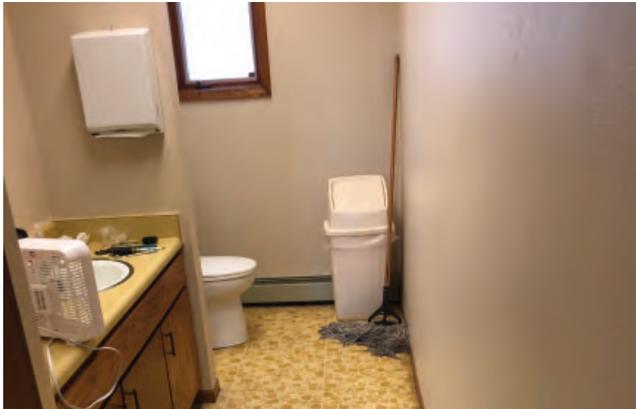
Restroom

ments are outside the parameters of current codes and the American's with Disabilities Act (ADA) requirements. It is recommended that the restrooms be renovated to comply with current codes and updated interior finishes.

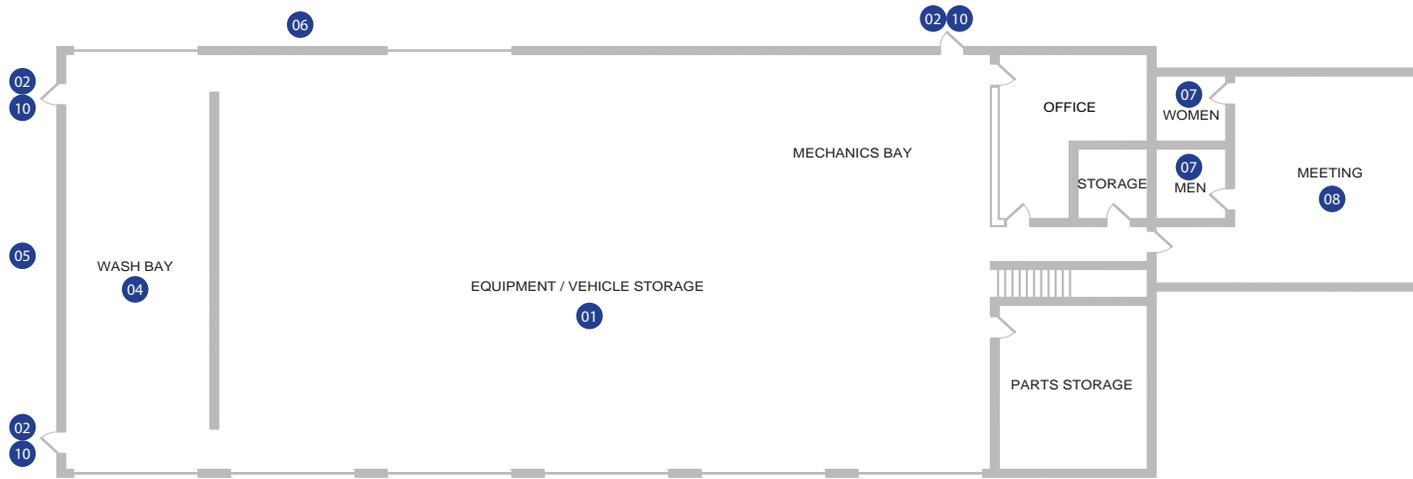
Shop Building - Main Level

- 02 Typical throughout building
- 03 Typical throughout building
- 09 Typical throughout building

- 09 Further investigate possible microbiological growth in existing roof insulation and replace as required to eliminate possible contamination.
- 10 Paint or replace exterior steel doors and frames to protect doors from corrosion.

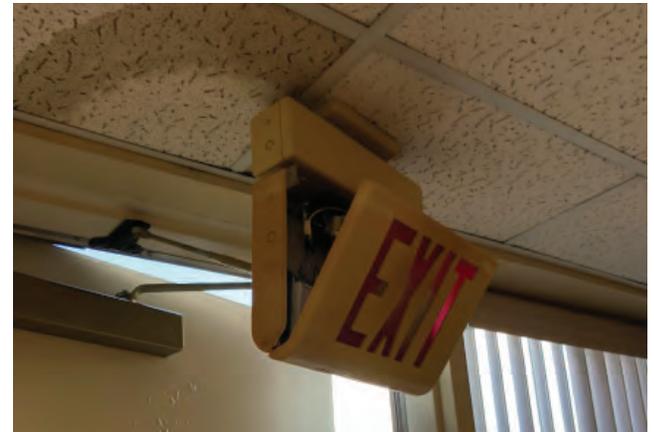
Emergency Lighting

Recessed emergency lights with two adjustable heads and battery backup are installed in the building. It is unknown if the batteries are replaced on a regular basis and tested monthly. All emergency lights should be tested and replace any lights that fail.

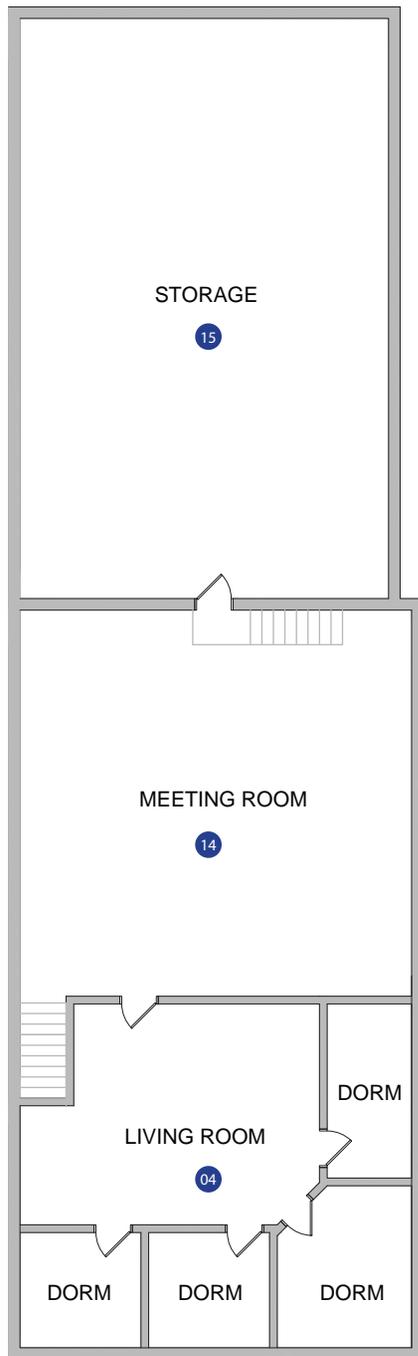
Upper Level

- 08 Typical interior
- 13 Typical exterior

- 03 Replace kitchen hood over stone/range with a hood that includes proper fire protection features.
- 04 Verify life safety features (sprinkler and fire alarm systems) for upper level sleeping rooms.

- 05 Provide proper grounding of the electrical systems.
- 06 Conduct an arc flash study and install proper labels on electrical gear.
- 07 Replace one existing outdated electrical panels.

- 08 Replace interior floor and ceiling finishes to provide an up-to-date appearance.
- 09 Provide accessibility upgrades to the existing facility restrooms to meet the minimum requirements of the American's with Disabilities Act (ADA) and State Building Code. Current plumbing fixtures do not meet current code minimum clearances or mounting heights. Complete restroom renovations are recommended.

- 11 Paint exterior steel doors and frames to protect doors from corrosion.
- 12 Replace existing overhead garage doors and door weather-stripping.
- 13 Tuck-point approximately 25% of the exterior masonry wall surface.
