Baxter County Quarry - 488 COUNTY ROAD 69

WTR - Complaint Form

Complaint Report

Investigation & Action Taken

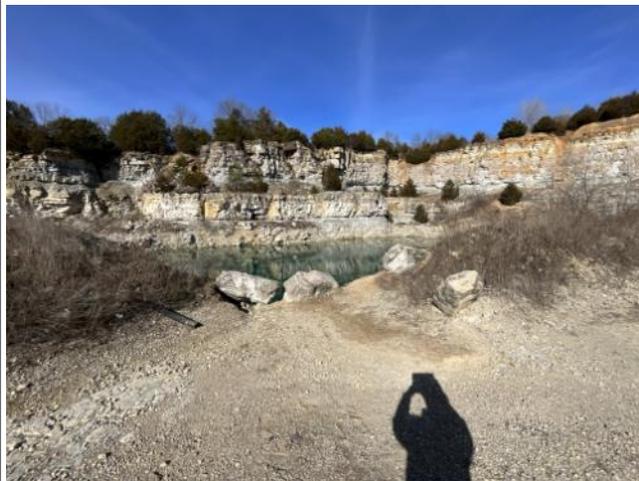
Photo Taken: 02/11/2026 10:13:00 AM
GPS Latitude: 36.289555
GPS Longitude: -92.323403
GPS Altitude: 284.743408 meters

North Arkansas Electric is utilizing a space in the quarry immediately inside the gate. However, no spills of chemicals was noticed while entering the area and the quarry. The only standing water located on site was the quarry pit. There wasn't any evidence suggesting wastewater was dumped into the pit that would cause elevated bacteria levels in drinking water. There wasn't any cloudy or dirty water leaving the mine site.

Photo Comment: View of the quarry pit standing at the southeast corner of the pit.

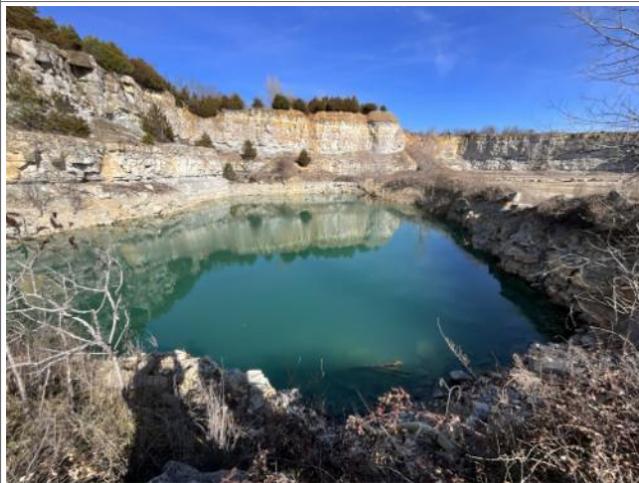
Photo Taken: 02/11/2026 10:14:00 AM
GPS Latitude: 36.289555
GPS Longitude: -92.323403
GPS Altitude: 284.743408 meters

Photo Comment: View of the quarry pit standing on the south end of the pit.

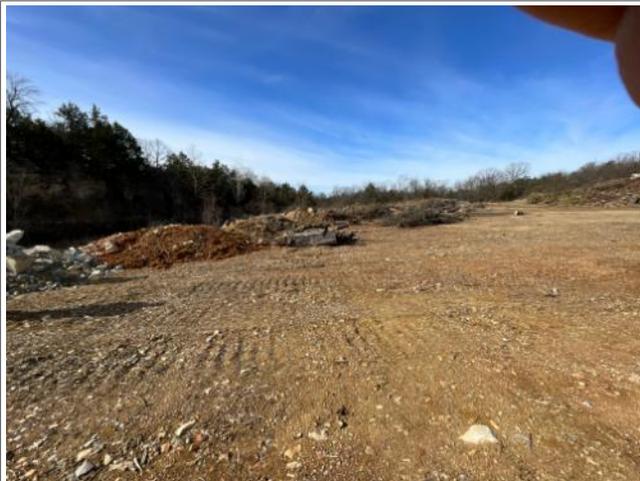
Photo Taken: 02/11/2026 10:49:00 AM
GPS Latitude: 36.284490
GPS Longitude: -92.321643
GPS Altitude: 264.566742 meters

I conducted an unannounced complaint evaluation of the site on February 11, 2026. Baxter County Judge Kevin Litty, Baxter County Road Department Superintendent Larry Carter, and E&E Inspector Jon Vickery were in attendance. The evaluation was conducted to address water quality concerns from alleged dumping of wastewater and dirt into a quarry pit (36.286028 and -92.32255) filled with water. The complaint alleged the pit is filled with dirt and whatever chemicals due to the disposal of drilling mud into the pit. At the time of the evaluation there wasn't any evidence that drilling mud had been released into the pit. Mr. Carter explained the pit is approximately forty feet deep. The pit contained water which was clear and Mr. Carter explained residents will fish in the pit for catfish. There was a single blue hose in the pit that is used so the County Road Department can withdraw water into water trucks. According to Judge Litty, Black Hills Energy was allowed to dump drilling mud from small containment trailers on the site, but not into the pit. The drilling mud was dumped onto the ground approximately 260 feet southeast of the pit. The drilling mud was not evident because a large pile of tree debris now sits atop the area. The dumping of drilling mud at the site was stopped in August or September 2025. If the County wishes to resume the dumping of drilling mud onto the site, the County must first contact the Division of Environmental Quality, Office of Land Resources to inquire about using the drilling mud as beneficial fill material.

Photo Comment: View of area where fill material is being brought into the quarry.

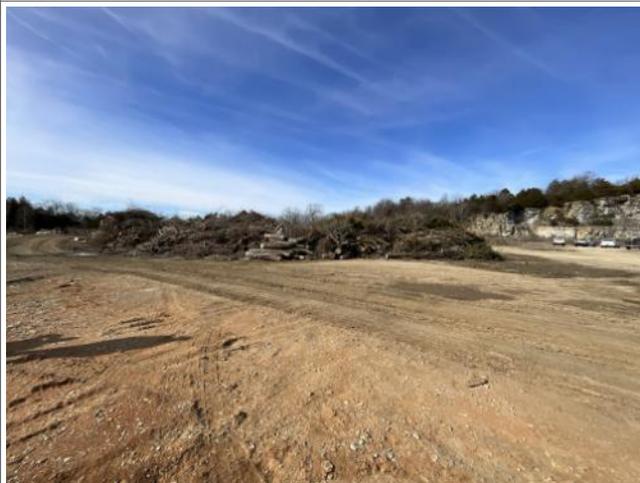
Photo Taken: 02/11/2026 10:49:00 AM
GPS Latitude: 36.284431
GPS Longitude: -92.321294
GPS Altitude: 295.928644 meters

The County allows North Arkansas Electric to bring in tree debris and pile it in preparation to be burned. However, tree debris from the County and North Arkansas Electric has been placed around the edge of the of the fill area because the County does not want the pile to get any larger prior to burning. Tree debris is not considered a beneficial fill material so please ensure it is not buried. It was recommended to Judge Litty that he begin a second tree debris pile staging area.

Photo Comment: View of tree debris pile that is being brought to the site by North Arkansas Electric.

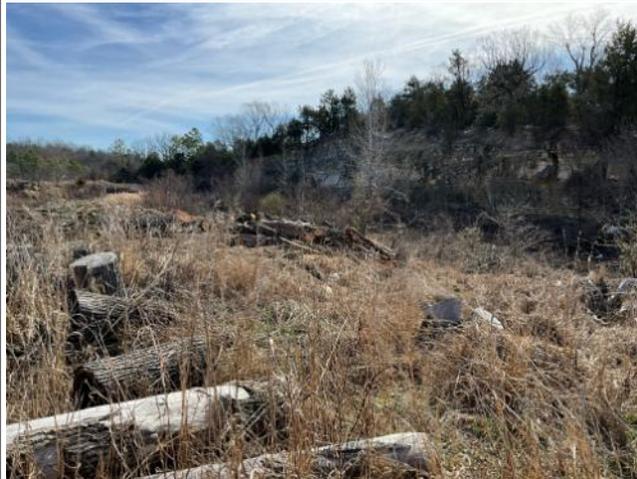
Photo Taken: 02/11/2026 10:52:00 AM
GPS Latitude: 36.284490
GPS Longitude: -92.321643
GPS Altitude: 264.566742 meters

Photo Comment: Other tree debris to the southeast of the proposed burn pile. Some had existed there that the County placed, and some was placed there by North Arkansas Electric so the existing pile did not increase in size.

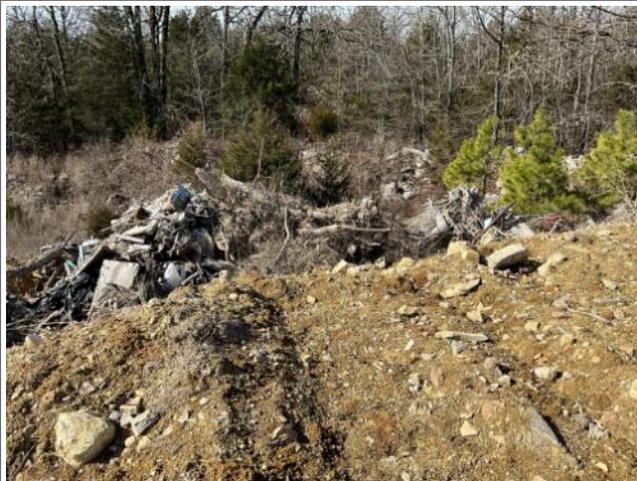
Photo Taken: 02/11/2026 10:55:00 AM
GPS Latitude: 36.284490
GPS Longitude: -92.321643
GPS Altitude: 264.566742 meters

To the south of the tree debris pile was solid waste that had been partially buried. Mr. Carter explained that people will dump materials at the quarry. I explained to Judge Litty and Mr. Carter that any solid waste that is dumped at the site must be disposed of at the landfill and not buried in the quarry. Judge Litty explained the materials would be removed.

No water quality violations were noted during the evaluation. However, the solid waste identified just south of the tree debris pile must be removed and disposed of properly.

Photo Comment: View of solid waste that was partially buried. It was recommended the waste be removed and disposed of at the landfill.

Remove solid waste that is photographed in #2 below and dispose of it properly at the landfill. Ensure no vegetative debris is buried on site. Contact the DEQ-Office of Land Resources prior to dumping any drilling mud onto the site if you wish to resume those activities. Monitor stormwater runoff from the site and install any necessary stormwater Best Management Practices if turbid stormwater is leaving the site or entering waters of the state. Monitor the area used by North Arkansas Electric to ensure any chemical or petroleum spills are remediated.

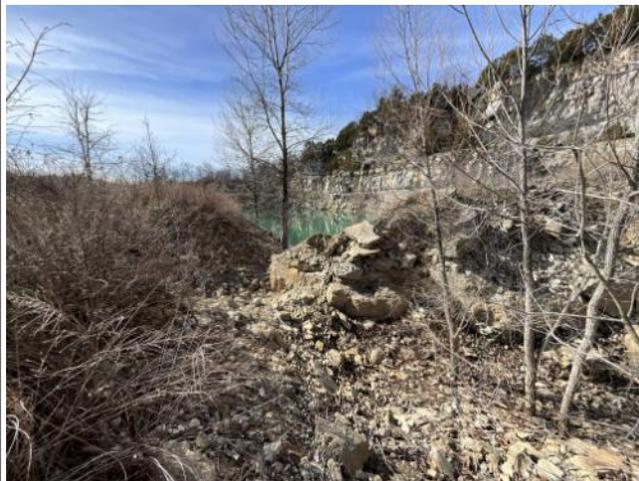
Photo Taken: 02/11/2026 11:03:00 AM
GPS Latitude: 36.284490
GPS Longitude: -92.321643
GPS Altitude: 264.566742 meters

Photo Comment: North side of the quarry pit where water would overflow with rising water levels.

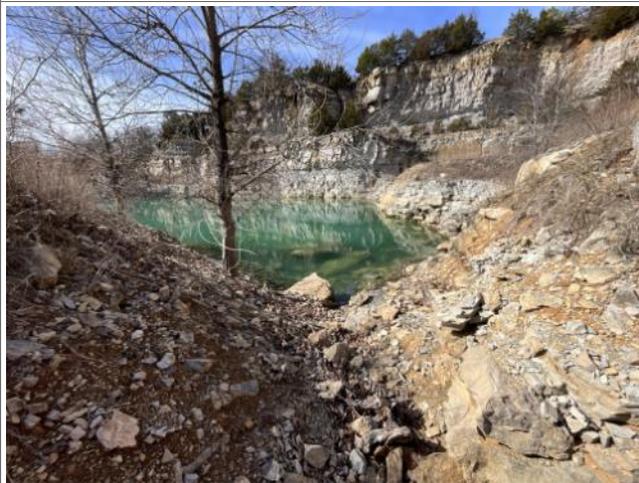
Photo Taken: 02/11/2026 11:03:00 AM
GPS Latitude: 36.284490
GPS Longitude: -92.321643
GPS Altitude: 264.566742 meters

Photo Comment: North side of the pit.

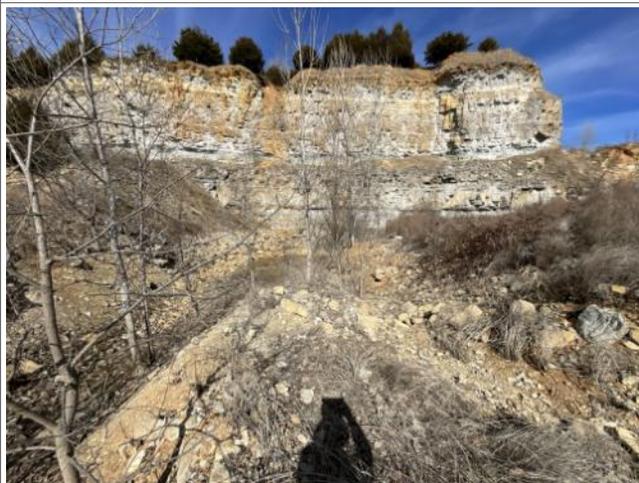
Photo Taken: 02/11/2026 11:04:00 AM
GPS Latitude: 36.284490
GPS Longitude: -92.321643
GPS Altitude: 264.566742 meters

Photo Comment: View from the northeast side of the pit looking north. Approximately fifty feet of elevation difference.
